This Service Information bulletin supersedes SI M17 08 12 dated **October 2012**.

SUBJECT

Service Action: Retrofit of the Engine Coolant Temperature Sensor

All with **automatic transmission** and either the N16 or N18 engine

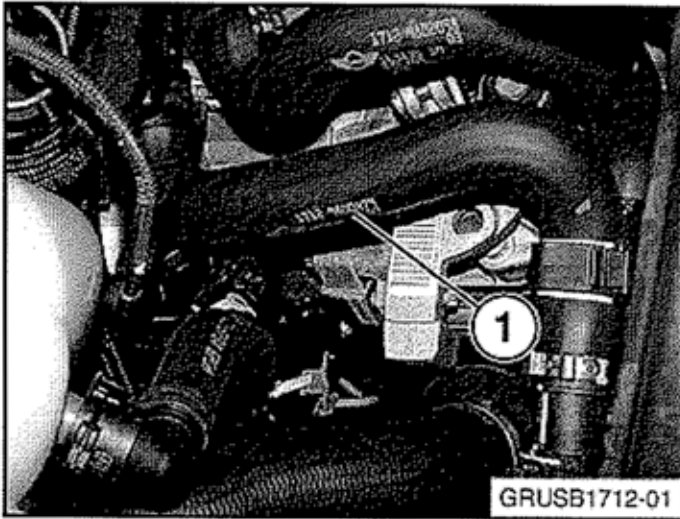
Remove the coolant hose (1). This hose will not be reused.

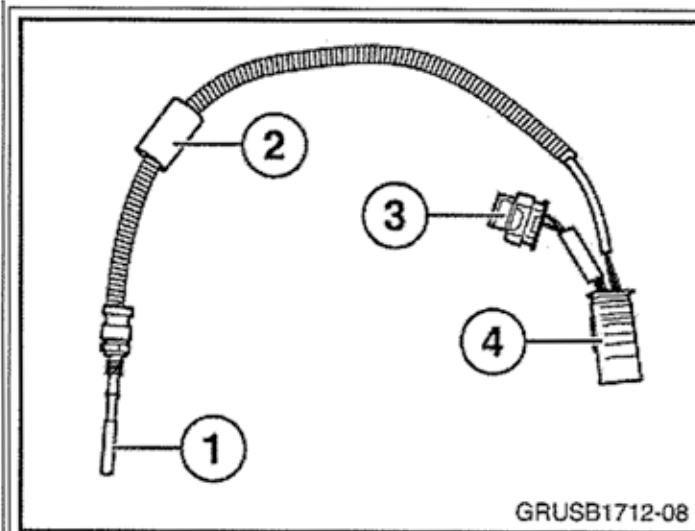
The improved sensor (P/N 13 62 8 603 908) includes the temperature probe (1) and insulating sleeve (2), a two-pin female connector (3) for the map thermostat, and a four-pin connector (4) for the engine harness.
